MOORING SNAP-BACK ZONES/AREAS

How they have changed over the years and what are the latest developments.

Panagiotis Stefanou

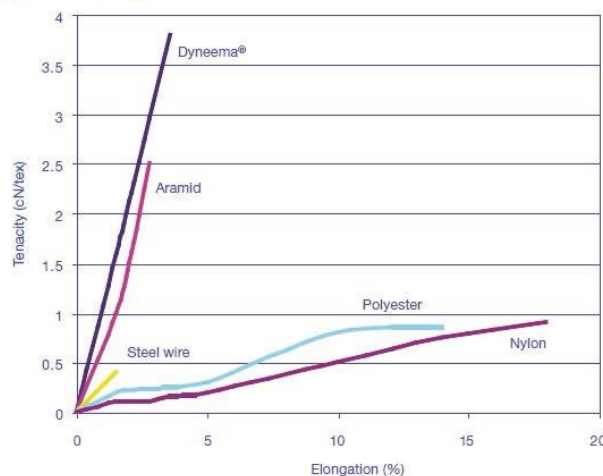
Figure: Tenacity elongation curves for various fibers.

Diagram 3: HMPE elongation comparison – Dyneema® and Aramid are HMPE type ropes (MAIB, 2017).

HMPE ropes are somewhat more elastic than wire, as can be seen in **diagram 3**, so they do also produce snap-back properties, despite different views (Caradec, 2022), albeit less than those of the other aforementioned synthetic ropes.

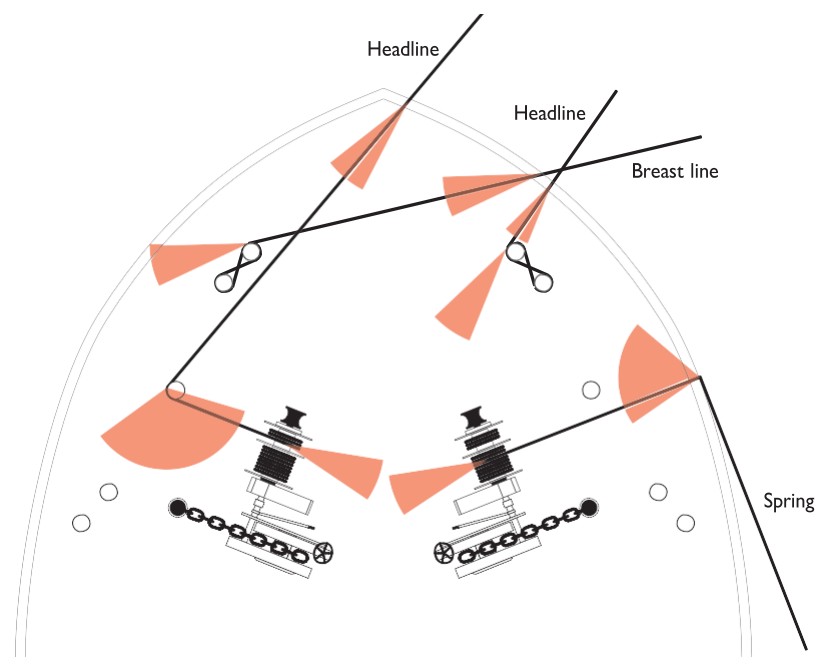
Diagram 4: A mooring deck arrangement illustrating potential snap-back zone areas (MCA, 2010, p.372).

To begin with, in order to make identification of risk areas easier, it is highly advised that a 'bird's eye view of the mooring deck' layout should be created. **Diagrams 4 and 5** depict mooring decks with snap-back zones painted (MCA, 2010, p.364).

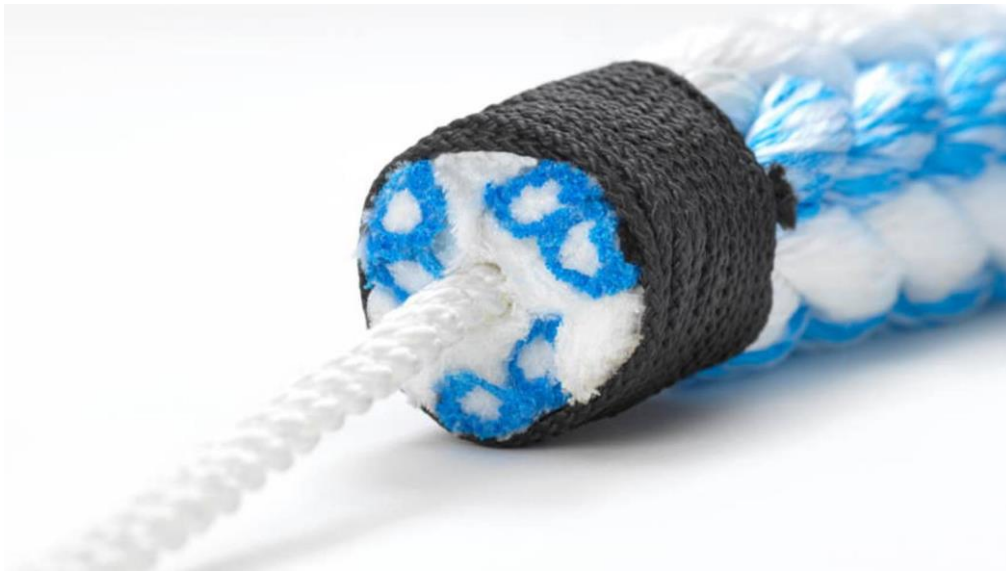
Diagram 8: An SBA rope (Wilhelmsen, 2023).

The arrestor also 'guides the broken strand(s) along the current axis of the rope, resulting in a significant reduction of snap-back' (op. cit.).

The SBA will begin to support the load and extend before breaking itself if the load is continued after the rope strands break. It can't support heavy loads, so when it breaks, it will release a lot less energy (op. cit.).
